TECHNICAL MEMORANDUM TM-2318-SHR

MOISTURE CURED URETHANE (MCU) COATINGS FOR USE ON ANTENNA TOWERS: A FEASIBILITY STUDY

July 1999

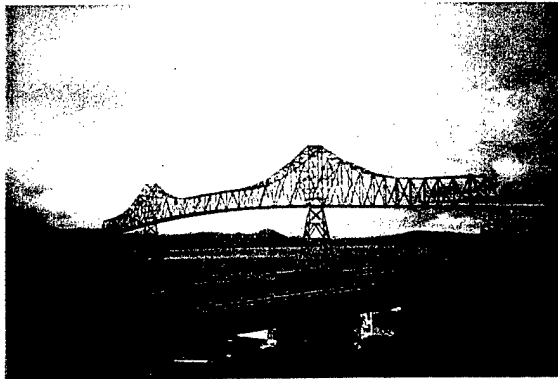
1. Astoria Bridge, Oregon Side.

Oregon's Department of Transportation (DOT) designated a section on the underside of the Astoria Bridge, located over the Columbia River on Oregon's Northwest coast, for testing potential bridge coating candidates. One study, which rated the performance of ten industrial coating systems over the course of six years, resulted in a MCU coating system (zinc rich primer, micaceous iron oxide intermediate, and an aliphatic topcoat) outperforming each of the nine tested coating systems. This study convinced Oregon's DOT to switch from their workhorse, two coats of either epoxy polyamide or epoxy polyamine followed by a topcoat of two-component aliphatic urethane, to coating systems consisting of MCU. At present, the Astoria Bridge contains MCU coating systems that have been in service for up to six years with, in general, high levels of performance (less than 0.5% coating failures). However, Oregon's DOT is experiencing some mild coating problems, on Astoria's Washington side, that are believed to be a result of improper application. Oregon's DOT feels that this is an isolated situation and anticipates a minimum of fifteen years maintenance-free service for MCU coating systems applied to coastal bridges. When comparing Oregon's past experiences with coating systems on coastal bridges, fifteen years of service, without overcoating, equates to a three-fold service life increase⁴.

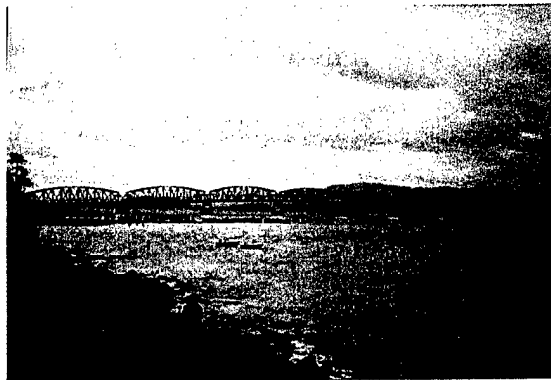
2. Astoria Bridge, Washington Side.

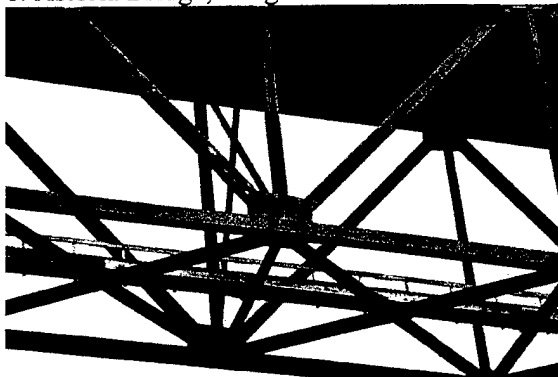
3. Close-up of Oregon Side.

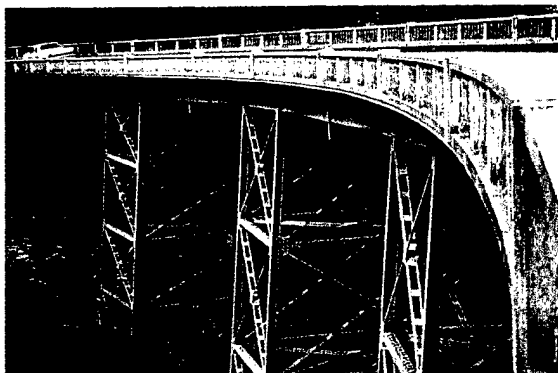
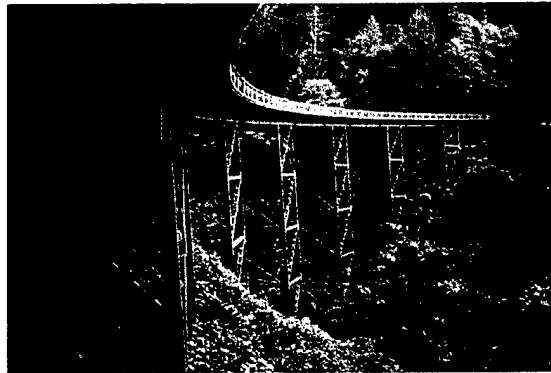
5. Manzanita Bridge, Oregon.

6. Manzanita Bridge, Oregon.

Oregon's Manzanita Bridge, located approximately one mile from the coast, was coated using an MCU coating system in 1989. At present, the coating system is performing quite well with less than 2.0 % visible rust, primarily located on edges. Oregon's St. John's Bridge, located a few miles west of Portland, is coated on the south side with a MCU coating system applied approximately five years ago. The coating system is in excellent condition with only negligible quantities of visible rust. However, the color of the guard railing, when compared to the bridge's underside, has faded several shades from its' original vibrant green to a light green pastel color. This observation implies that either the coating's green pigment or the MCU resin matrix is effected by sunlight and is degrading.

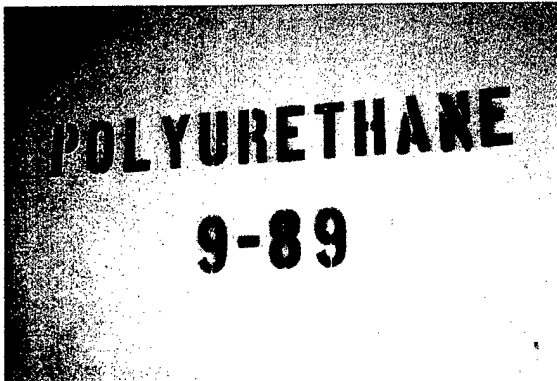
7. MCU on Manzanita Bridge since 1989.

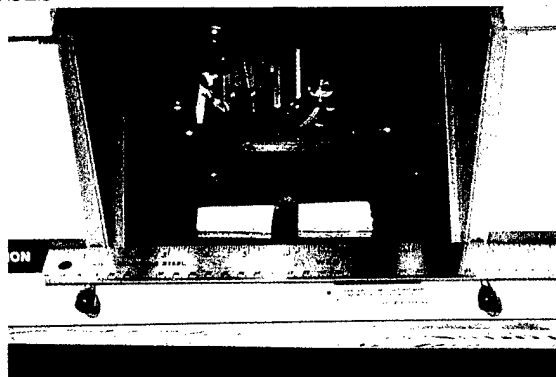
11. Bio Rad™ Fourier Transform Infrared Spectrometer (FTIR).

A Bio Rad™ Fourier Transform Infrared Spectrometer (FTIR) was used to chemically fingerprint each of the white and red-orange topcoats evaluated. Appendix B contains spectral printouts and a written summary detailing significant absorption peaks, functional groups identified, and a brief description of the results. FTIR results provided insight into the chemical formulation of the topcoats and, in addition, will be useful in establishing baseline quality control parameters if future coating specifications are to be designed.

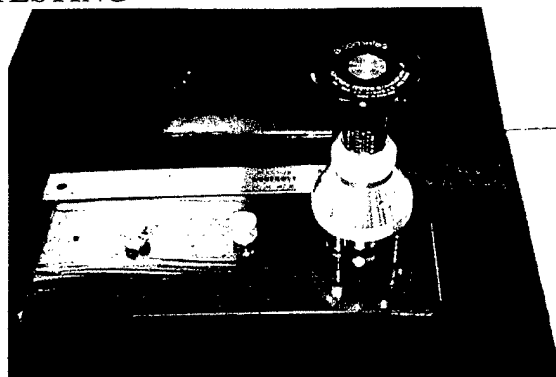
12. Elcometer™ Portable Adhesion Tester with 3/4" Aluminum Pull-Off Coupons.

Adhesion testing in accordance to ASTM D 4541 (Standard Test Method for Pull-Off Strength of Coatings Using Portable Adhesion Testers⁵) was performed on coating systems applied under both standard (dry) and wet surface conditions. Three 3/4" aluminum pull-off coupons were glued, using a two-component five minute epoxy, to four test panels per coating system: white topcoat (dry), white topcoat (wet), red-orange topcoat (dry), red-orange topcoat (wet). It became apparent, when pulling-off the aluminum coupons, that the selected adhesive was significantly weaker than the coatings tested. Numerous glue failures occurred well before maximum coating adhesive strengths could be quantified. Nevertheless, all coating systems applied under the standard dry conditions developed sound coating bond strengths, to both the substrate and to intercoats, at or above 400 psi. All coating systems applied to wet surfaces experienced bond strengths at or above 280 psi with disbonding primarily resulting from intercoat and substrate adhesion loss. Results from wet surface adhesion testing indicate

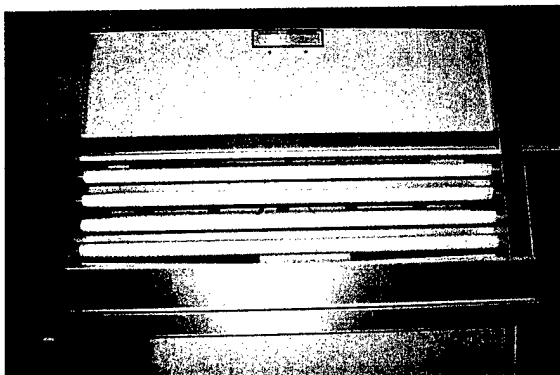
13. QUV Accelerated Weathering Tester.

Four coated test panels (two white topcoat, two red-orange topcoat) per coating system were placed into two QUV Accelerated Weathering Test Units. Each QUV unit ran for a total of 3,000 hours and was programmed to run on one of the following two Schedules: 1) Alternating cycling between 4 hours water spray without UV (70°F) and 4 hours heating with UV (140°F), and 2) Continuous heating with UV (140°F). QUV testing was performed to determine color and gloss retention per topcoat and, in addition, overall degradation due to accelerated weathering. Both prior to and after QUV testing, topcoats were evaluated for Specular Gloss and UV/VIS Spectral Absorbance (see results below). In order to perform the UV/VIS spectral analysis, two additional samples (sample size: 2 in²) per coating system were placed into the QUV unit programmed with Schedule #2. After 3,000 hours exposure from either Schedule 1 or Schedule 2, test panels, in general, exhibited visually observed decreases in color and gloss retention as the primary signs of coating degradation except Coating System D (water-based Coating System D, subjected to Schedule 1, developed a bond, in the area of test panel/test rack overlap, which required significant force to remove: bond suggests that Coating System D may not be highly resistant to water). A decrease in both color and gloss retention was clearly observed when comparing exposed test panel surfaces to those covered by the test rack. Coated test panel areas covered by the test rack appeared several shades brighter with higher gloss than the adjacent exposed panel surfaces. When compared to the white topcoats, the red-orange topcoats contained the greatest degree of color retention loss.

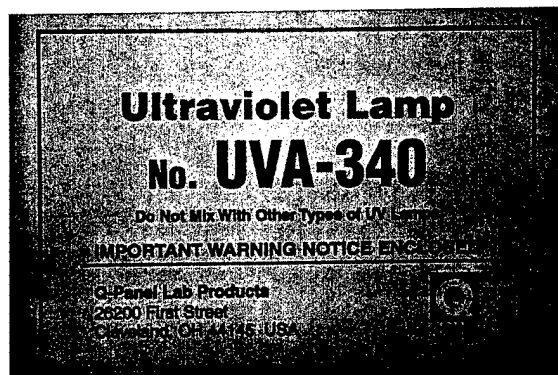
14. UVA-340 Bulbs were used in QUV.

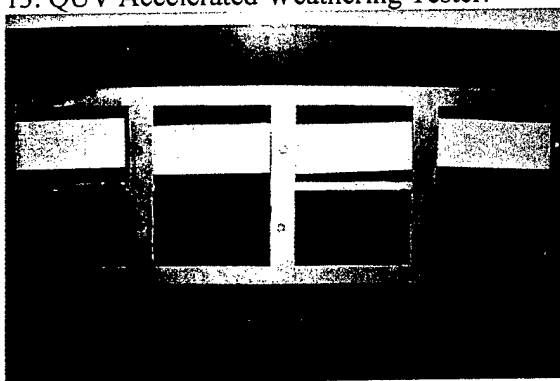
15. Sample Rack used for QUV.

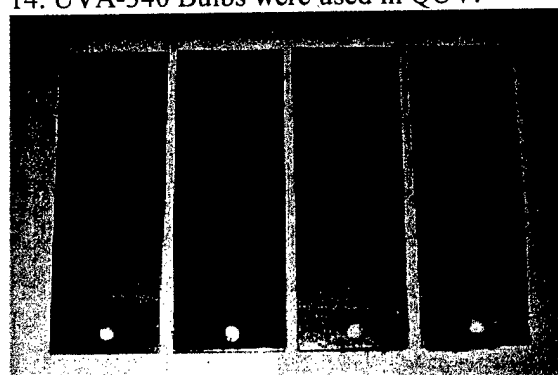
16. Samples after 3,000 hrs. Schedule #2.

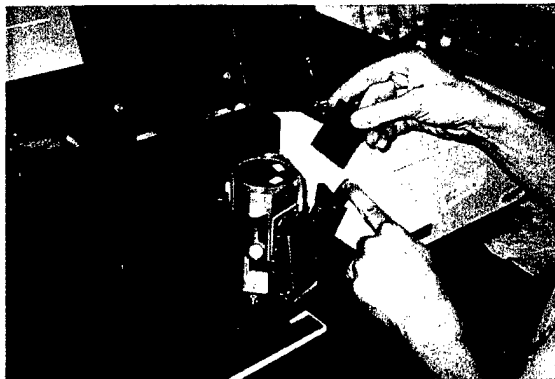
17. Perkin Elmer™ UV-VIS Spectrophotometer with 2" Sample.

A Perkin Elmer™ UV/VIS Spectrophotometer was used to evaluate color changes in coating systems subjected to 3,000 hours of Schedule #2 QUV exposure. For each topcoat, three two-inch square samples, cut from the 6" x 12" test panels, were used for the UV/VIS evaluation. Two samples per topcoat color were used to establish baseline visible and UV spectral parameters whereas the third was placed in the QUV and evaluated after 3,000 hours of Schedule #2 exposure. Appendix C contains two spectral printouts per coating system (white topcoat, red-orange topcoat) and shows the two baseline standards superimposed upon the UV exposed sample (absorbance in the visible range (VIS) is at a wavelength from 400 – 700 nanometers (nm), whereas absorbance in the ultra-violet range (UV) is from 200 – 400 nm). The UV-VIS instrument measures the amount of ultraviolet and visible energy absorbed by a coating and, in addition, may be used to correlate chemical changes within the coating. Although several coatings exhibited decreases in both gloss and color retention after QUV exposure, the UV-VIS spectral printouts did not conclusively show either significant increases or decreases in absorbance whereby spectral trends could be identified. Either further UV-VIS spectral analysis or other color analysis is required to quantitatively determine the subtle trends within each spectral printout.

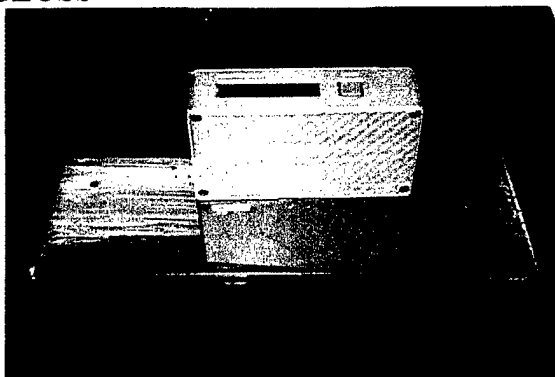
18. Gardco® micro-TRI-gloss: Specular Gloss Unit (20°, 60°, 85°).

A Gardco® micro-TRI-gloss was used at an angle of 60° to evaluate specular gloss on four test panels per coating system, both prior to and after QUV exposure (two panels per Schedule). Gloss values are presented in Appendix D and represent the average of ten readings per gloss value. The specular gloss scale ranges from 0 – 100 where high gloss

surfaces contain values greater than 85 at a 60° angle. The highest initial gloss value for white was 85.6 (Coating System H) and the highest initial gloss value for red-orange was 84.5 (Coating System E). A shift in specular gloss, such as a gloss decrease, represents a surface that has begun to degrade. However, twelve out of the thirty-two panels evaluated actually exhibited a gain in specular gloss following QUV exposure. One potential explanation is that several of the coated panels retained the high and low ridges resulting from application by brush. These ridges may have affected the accuracy of the gloss meter's readings. Overall, the red-orange topcoats subjected to Schedule #2, except Coating System F, exhibited slightly higher decreases in gloss when compared to their white counterparts (Coating System F's initial gloss value prior to Schedule #2 exposure was 25.1 which shifted to the lowest recorded value of 11.8). However, differences in the gloss values between red-orange and white topcoats do not appear to be significant and, as such, these topcoats should lose their gloss at a rate approximately equivalent.

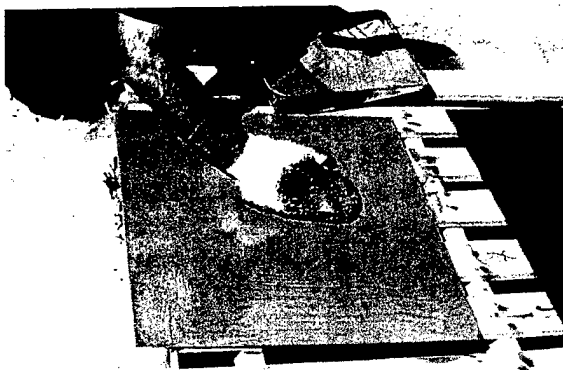
19. Application of Zinc Rich MCU by Mitt.

To simulate application procedures employed on Naval antenna towers, the following demonstration was performed. One 2' x 2' x 1/8" sheet metal panel (horizontal application) and one vertical surface of a steel wall were coated with one coat of a zinc rich primer (properties identical to those listed in Table 1) using a synthetic mitt with a 3/8" nap. One additional sheet metal panel was coated with one coat of the above zinc rich primer by brush (horizontal application). The Dry Film Thickness (DFT) of the primer applied to each panel was measured 30 hours following paint application using an Elcometer™ Model 345 Magnetic Gauge. Application by mitt produced DFTs ranging from 1.5 – 5.4 mils (1 mil = 1/1000 inch), whereas, application by brush produced DFTs ranging from 2.5 – 6.0 mils. MCU coating manufacturers recommend that DFTs remain below 3.0 mils per coat. Where DFTs were greater than 3.5 mils, bubbles (pinholes) were clearly visible. Pinholes allow water and salts direct access to the substrate whereby the coating, in the area of the pinhole, cannot protect the substrate against corrosion. Application by mitt produced runs and sagging on the vertical surface and, in addition, released synthetic fibers into the coating which may create a wicking effect. Wicking occurs when fibers become exposed and create a path of direct access for water and salts into the coating which, over time, may lead to a coating failure at the fiber's site. This demonstration identifies what may happen when a MCU is applied above 3.5 mils DFT and, in addition, the ease in exceeding 3.5 mils DFT when applying a MCU by either mitt or brush.

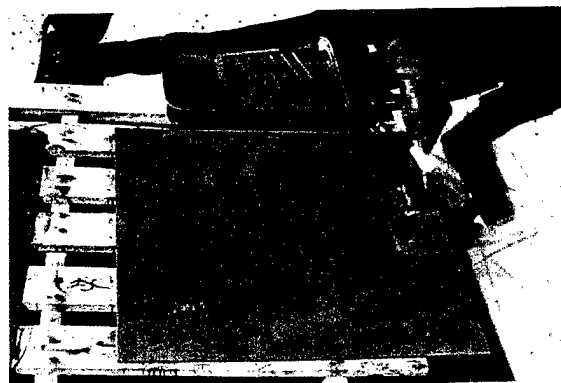
20. Application of Zinc Rich MCU by Brush.

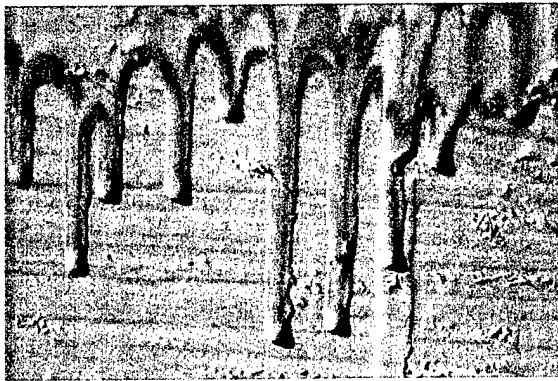
21. Fast application by mitt on a vertical surface using a Zinc Rich MCU produced unacceptable runs and sagging. One day following photograph, runs contained pinholes.

When humidity and temperature requirements are met and coating applications are at or below 3.0 mils per coat, MCU coatings appear to be protecting structures against corrosion at a level approximately equivalent to two-component formulations. However, MCU coating systems, in general, are unable to form pinhole free films when applied at DFTs greater than 3.5 mils.

5. MCU application by either mitt or brush, even under controlled conditions, may produce unacceptable pinholes due to Dry Film Thickness (DFT) greater than 3.5 mils.

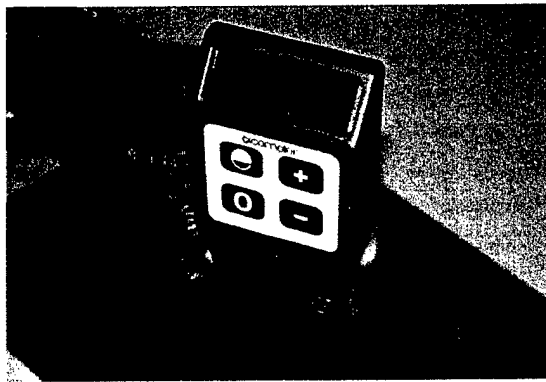
22. Elcometer™ Model 345 Magnetic Dry Film Thickness (DFT) Gauge.

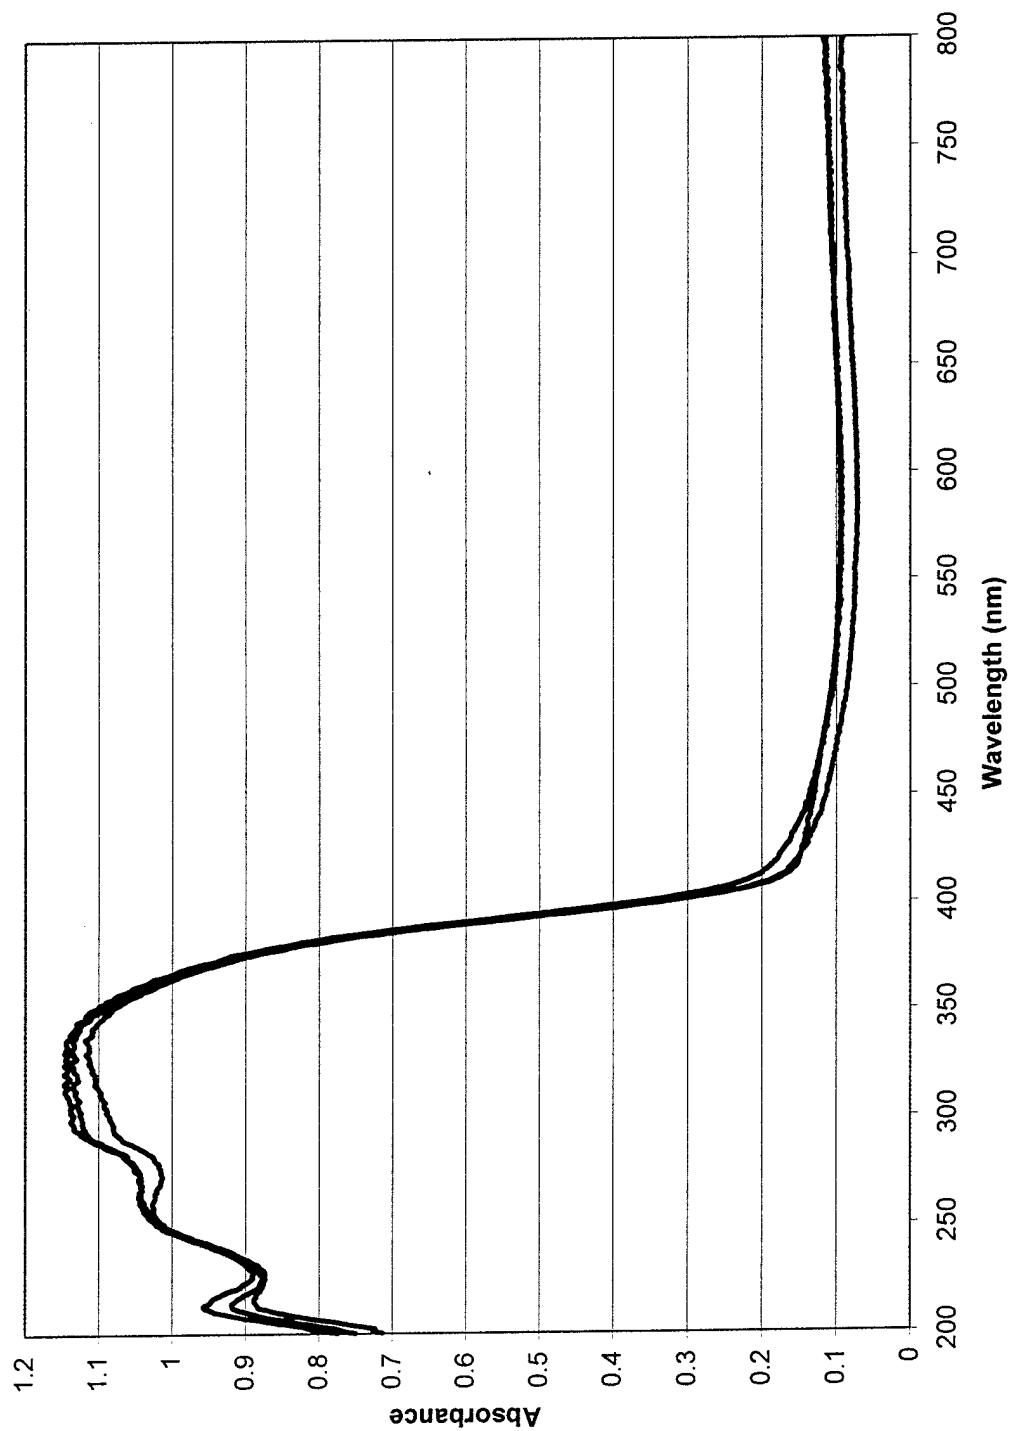
White Topcoat A

Controls and 3000 Hours UV Exposure

Control 1

Control 2

3000 Hrs UV
Exposure

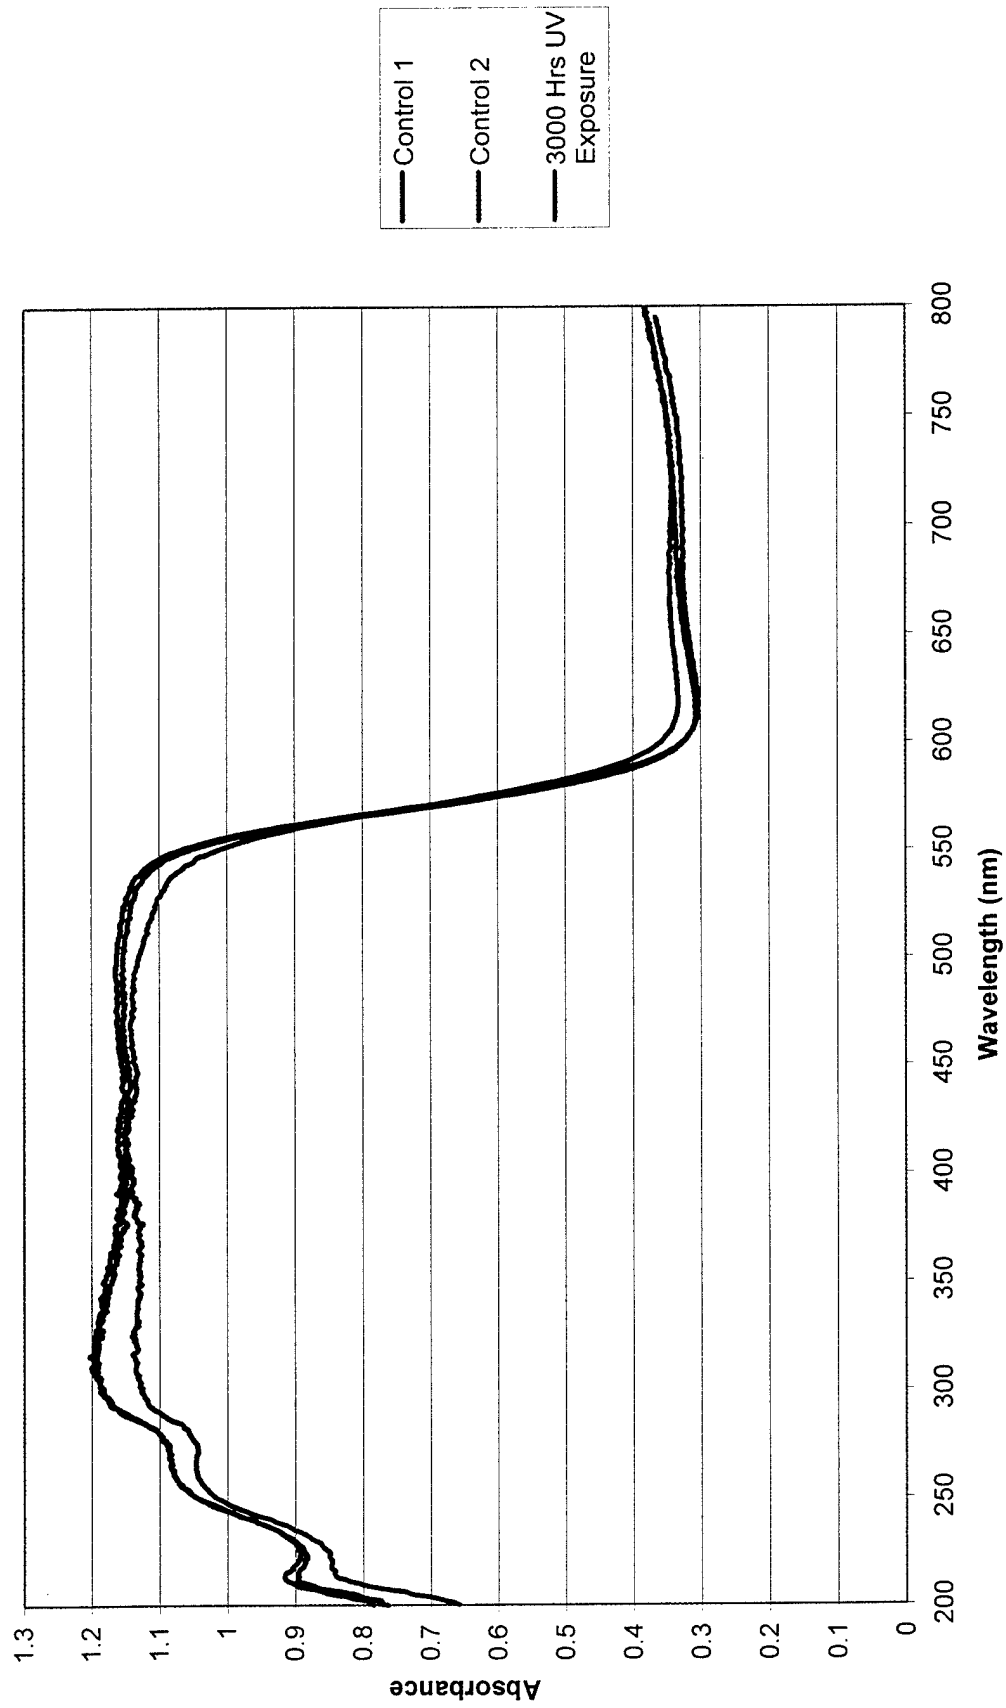
Red-Orange Topcoat A

Controls and 3000 Hours UV Exposure

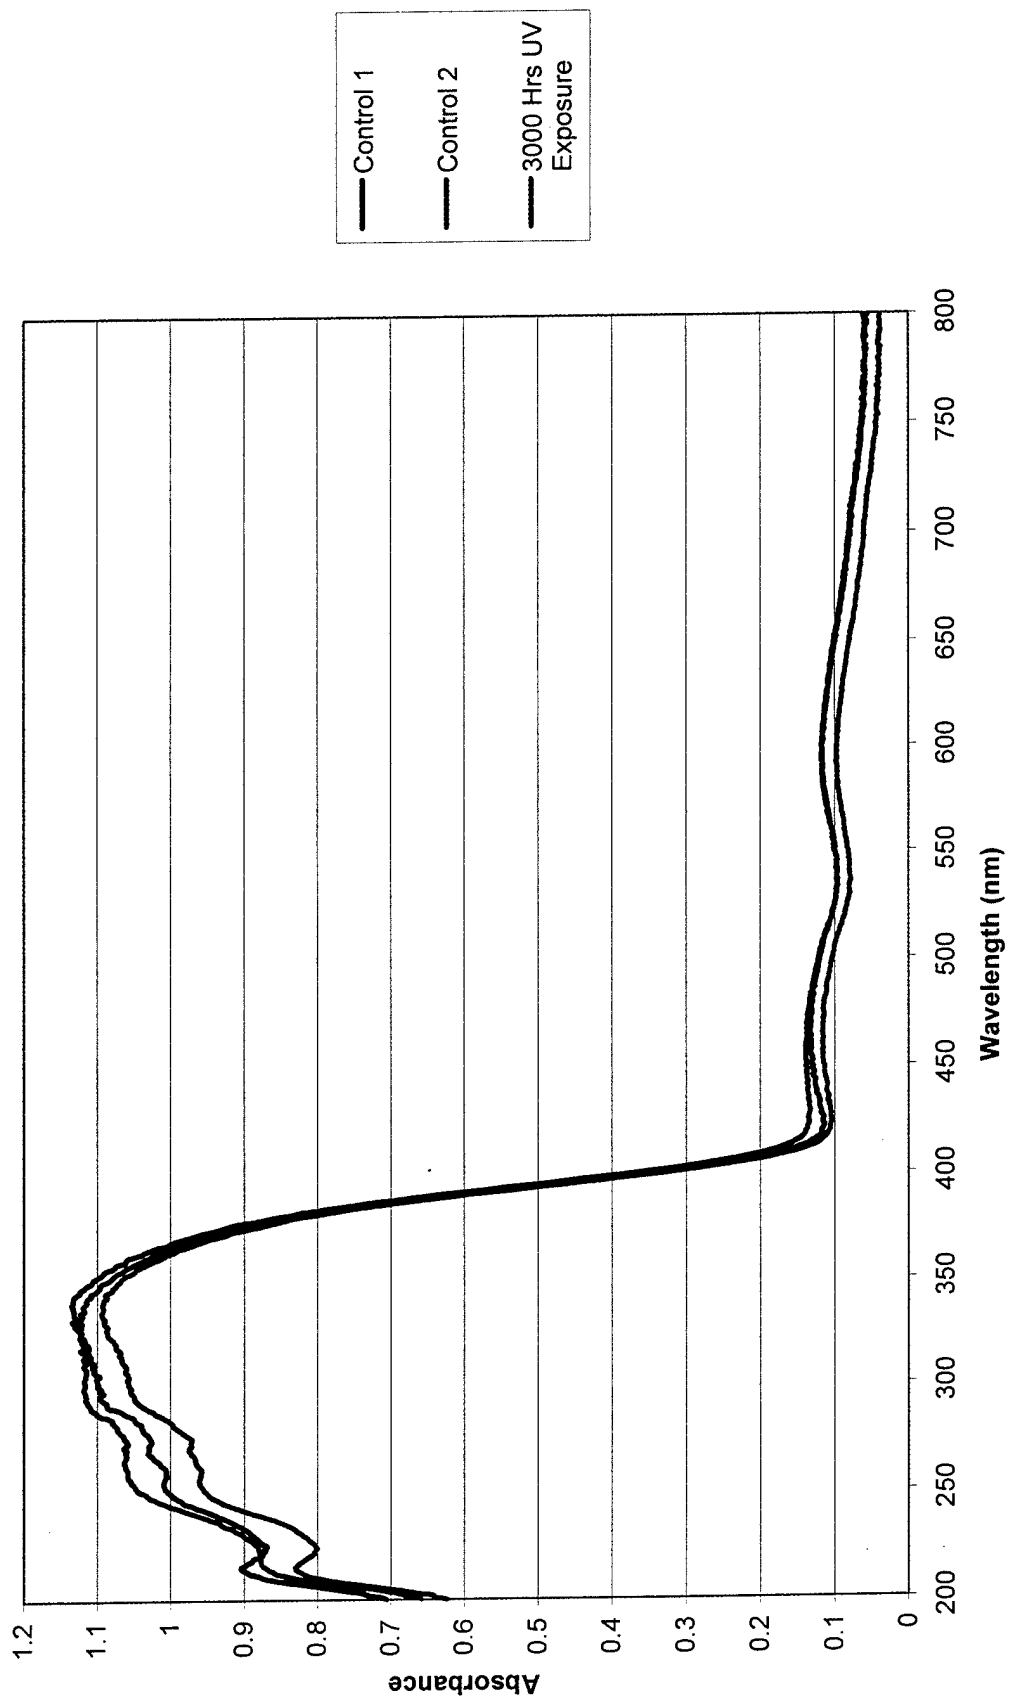
White Topcoat B

Controls and 3000 Hours UV Exposure

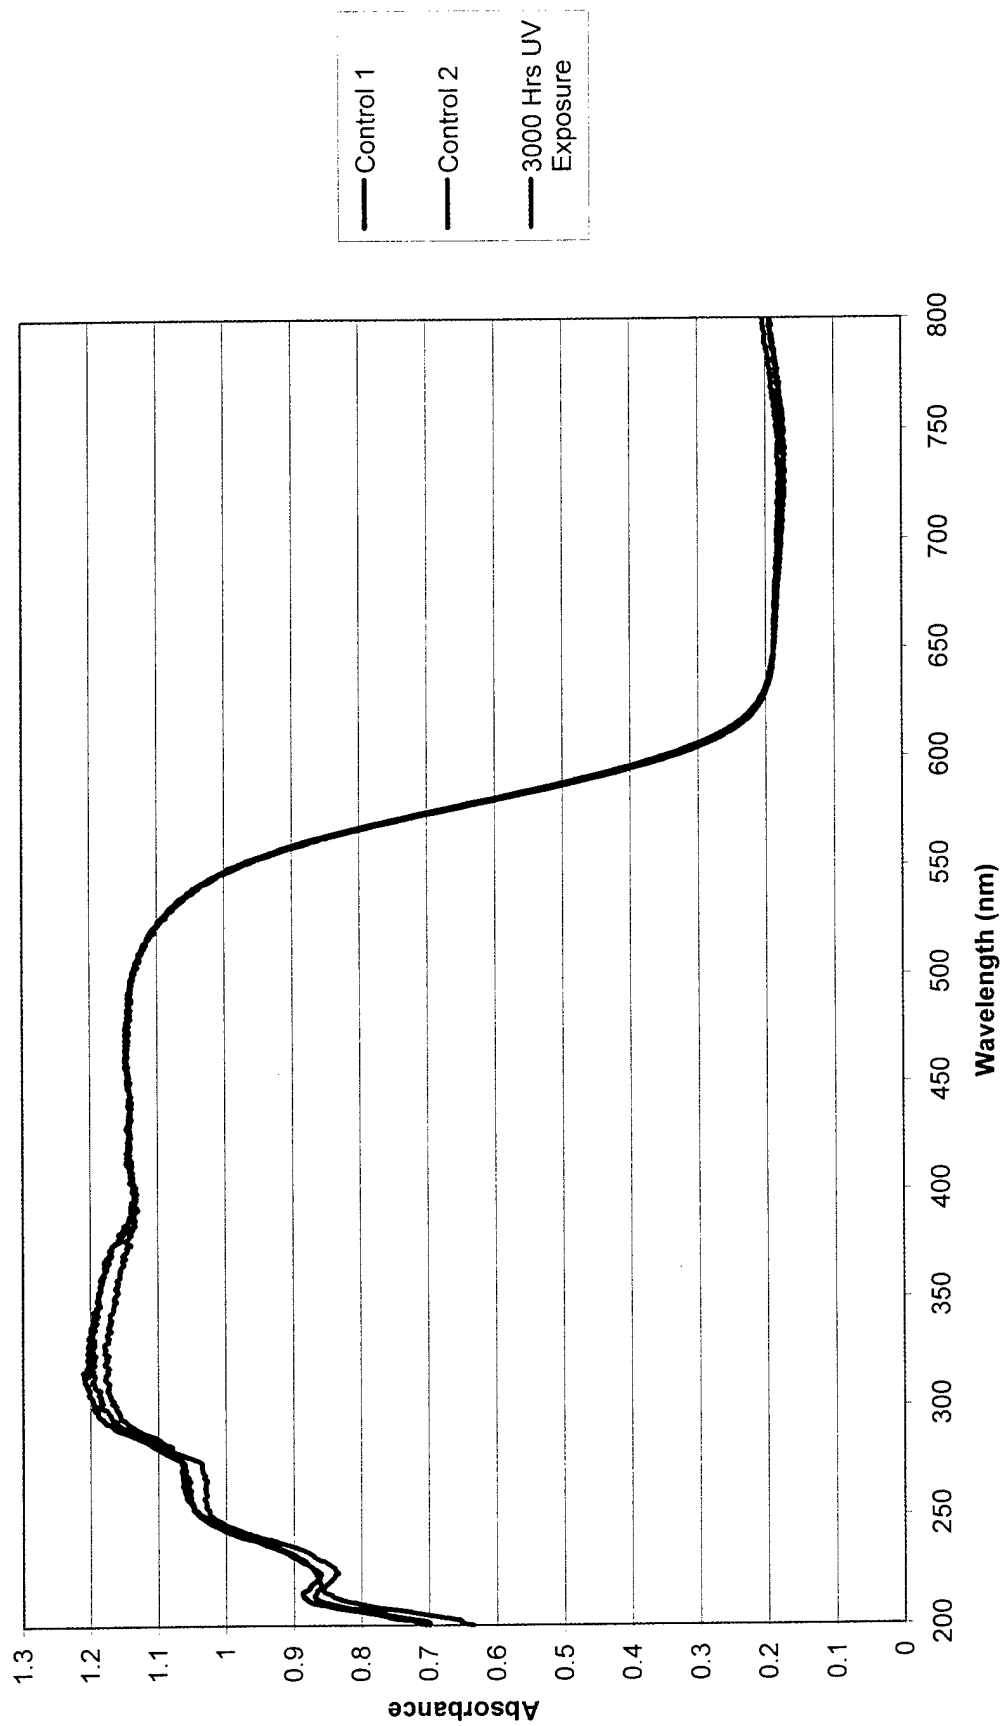
Red-Orange Topcoat B

Controls and 3000 Hours UV Exposure

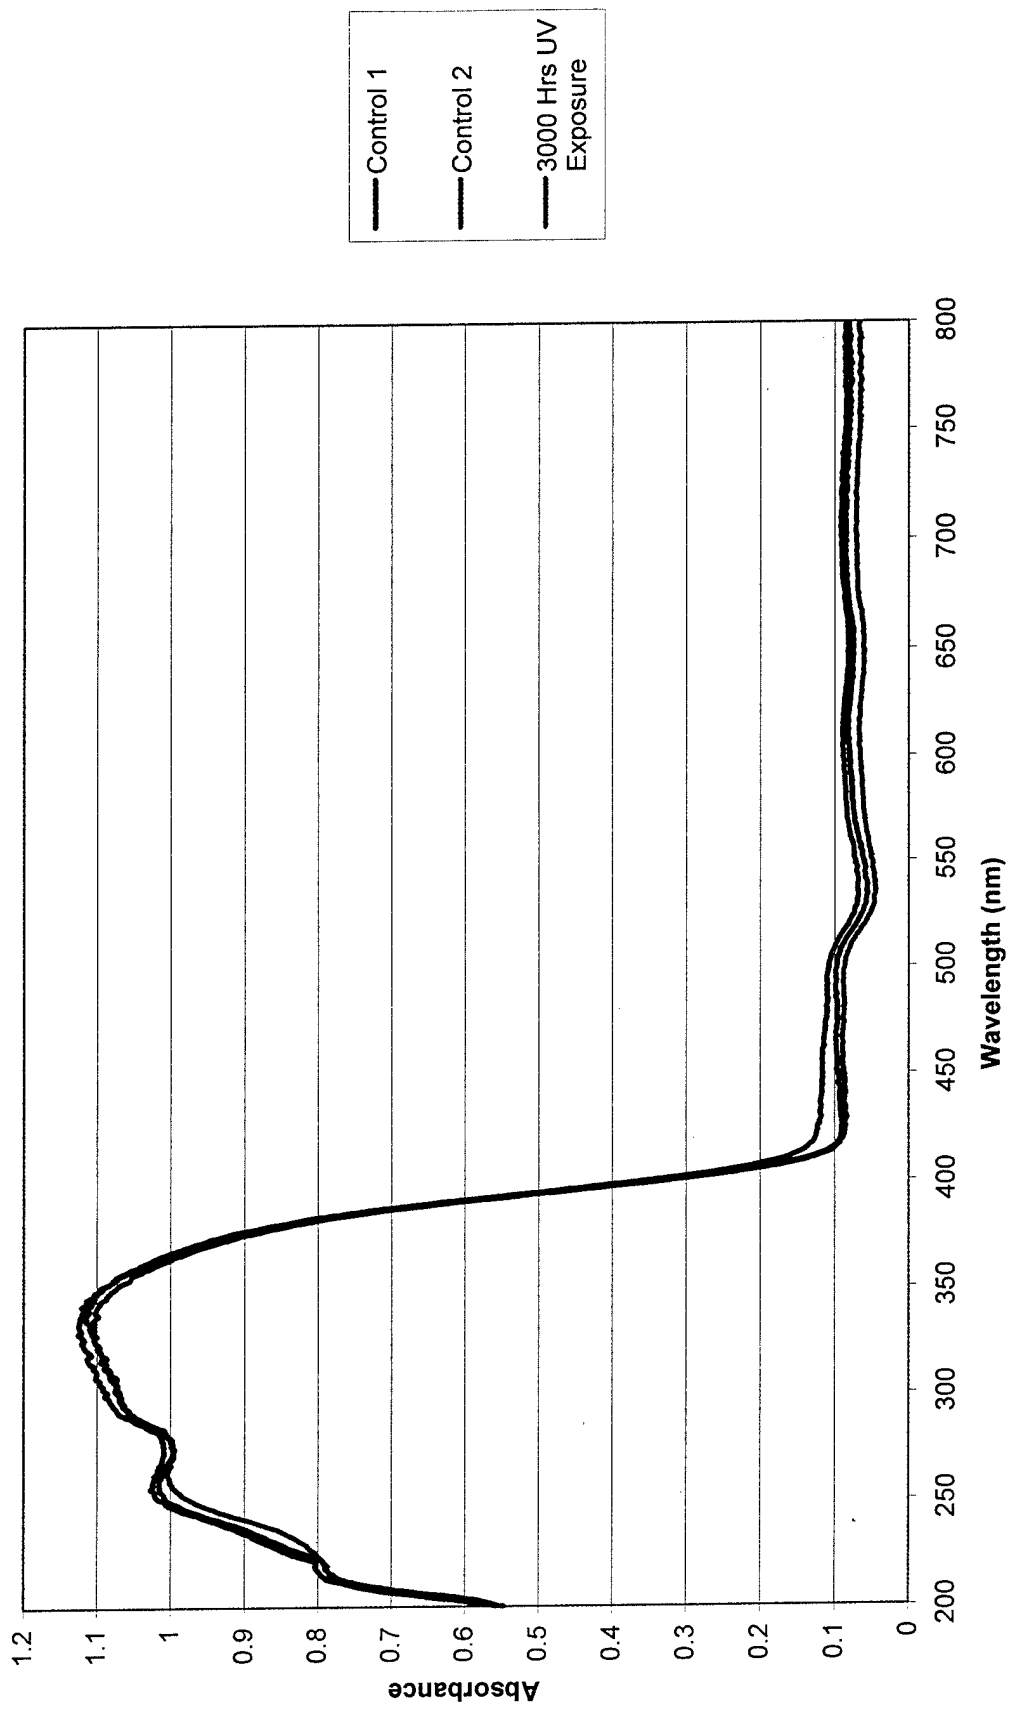
White Topcoat C

Controls and 3000 Hours UV Exposure

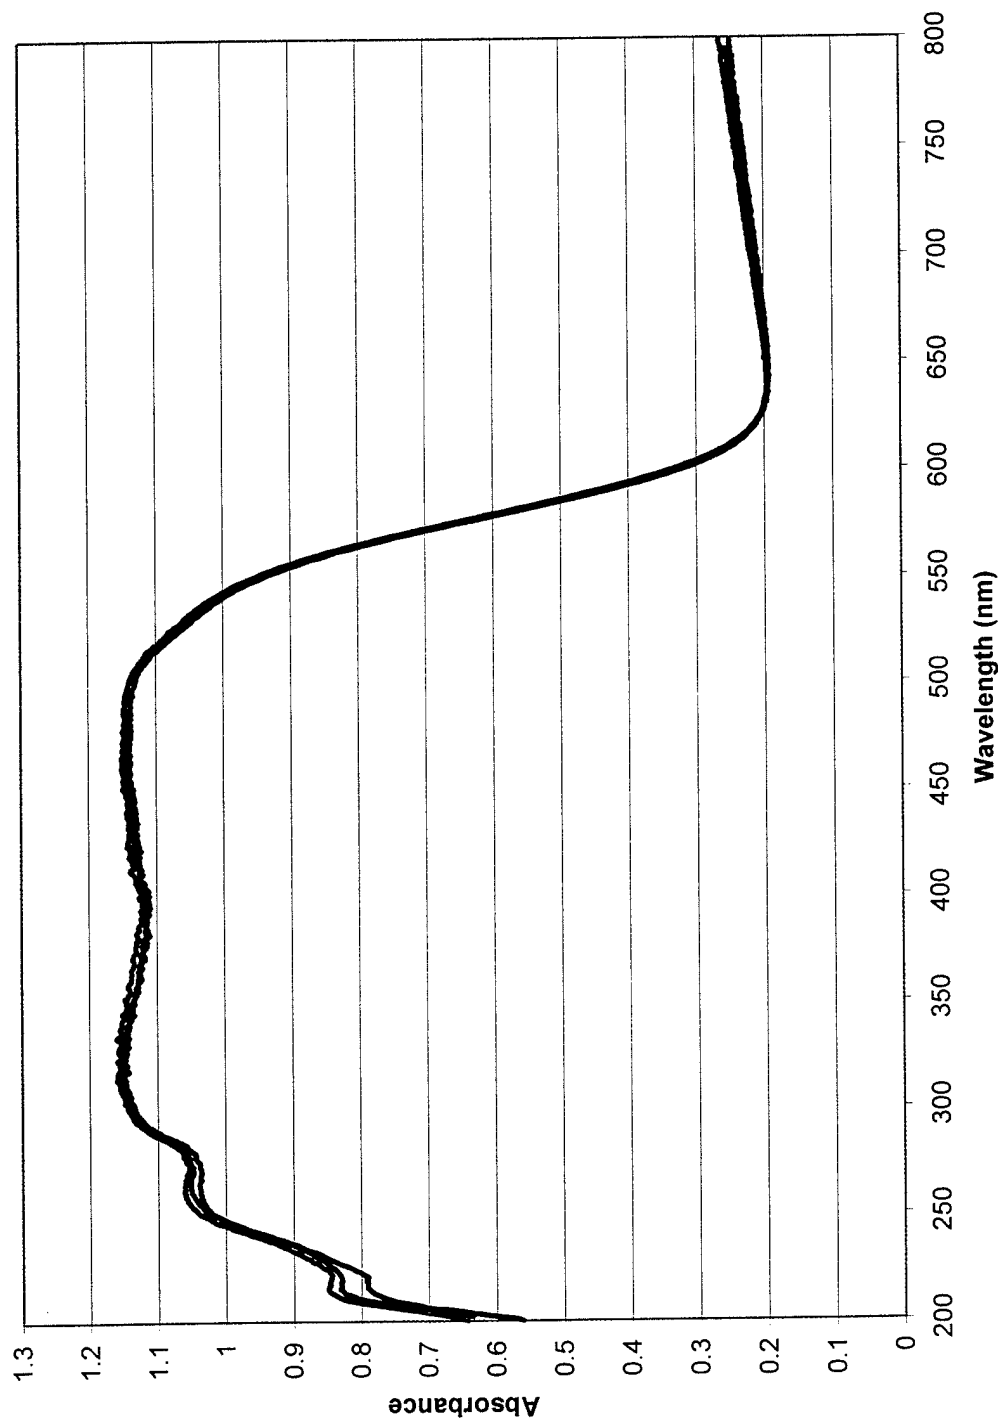
Red-Orange Topcoat C

Controls and 3000 Hours UV Exposure

Control 1
Control 2
3000 Hrs UV Exposure

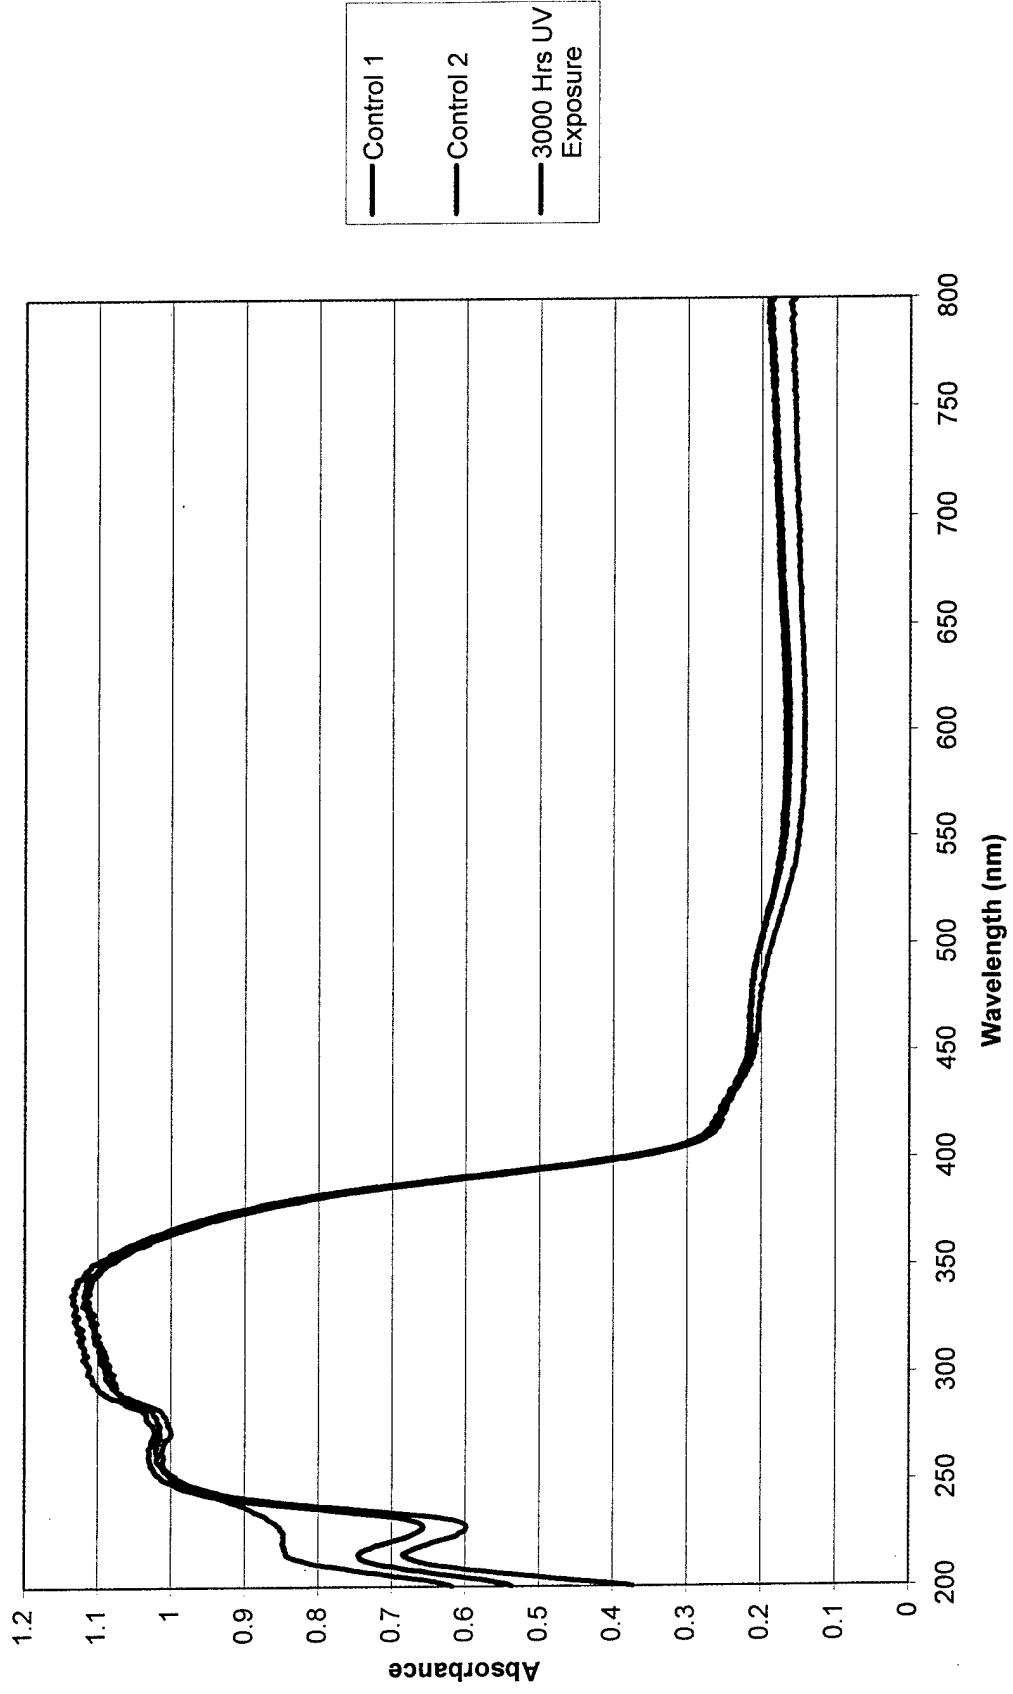
White Topcoat D Controls and 3000 Hours UV Exposure

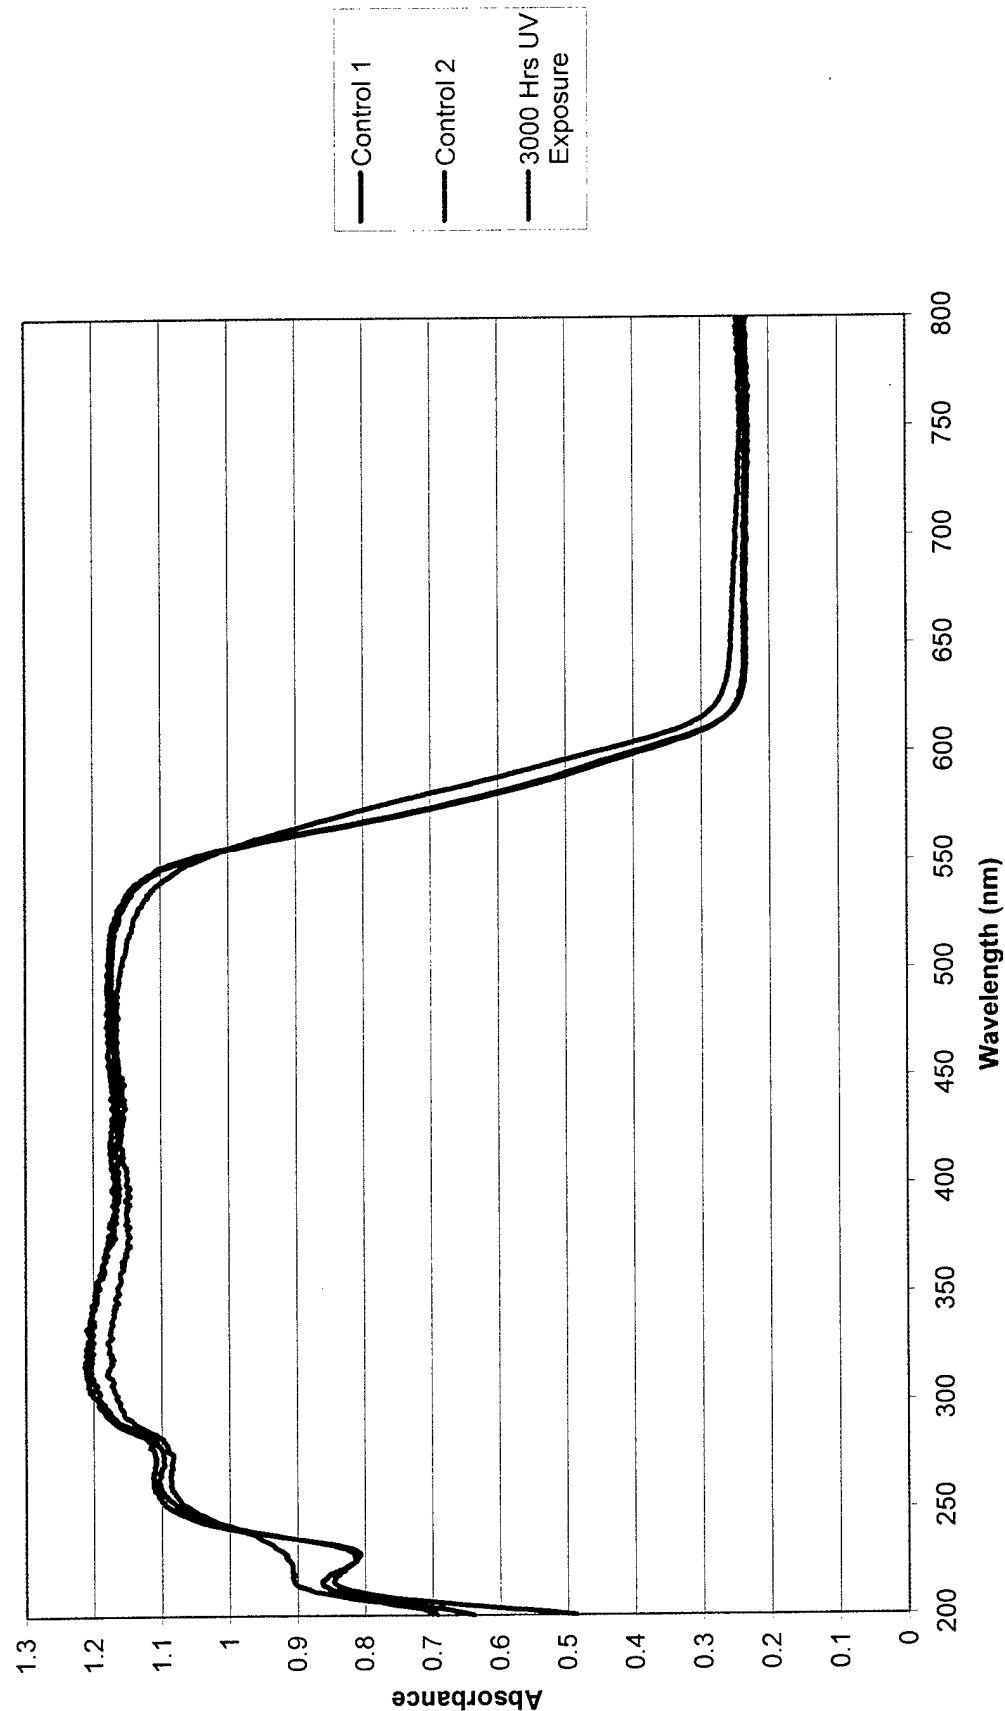
Red-Orange Topcoat D

Controls and 3000 Hours UV Exposure

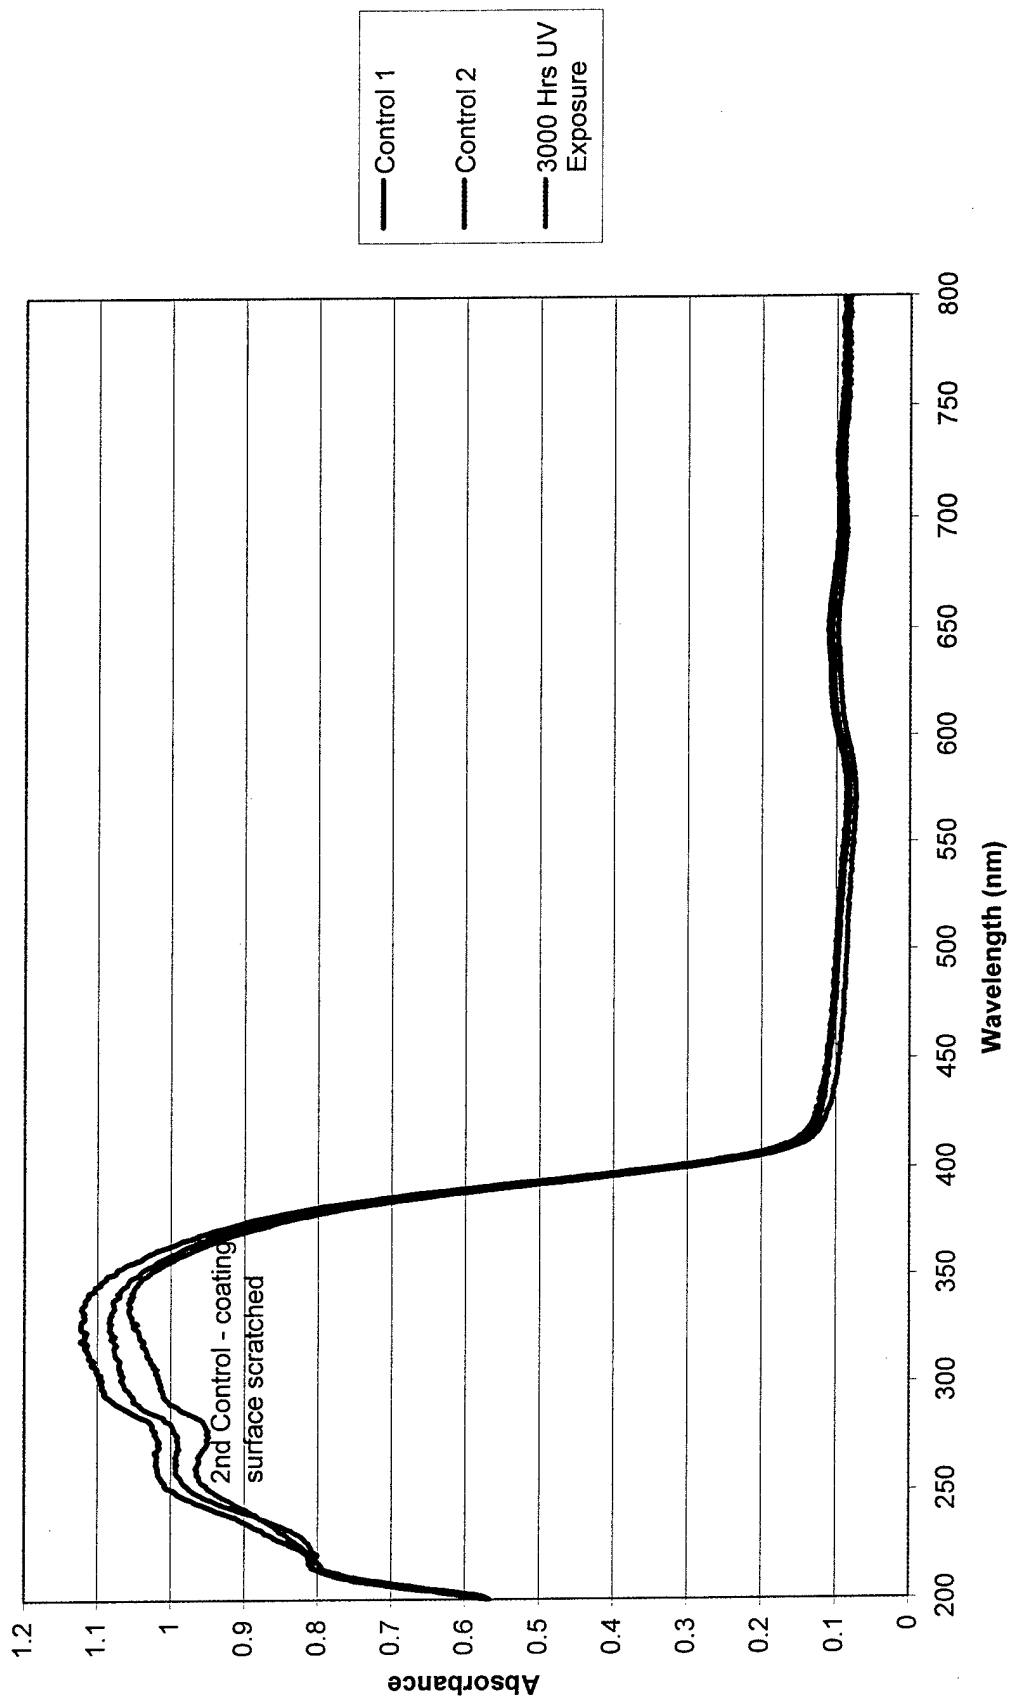
White Topcoat E

Controls and 3000 Hours UV Exposure
